Middle Tennessee Two-way Inc  
John Hettish  
01/08/02

Problem with FG3000/2000

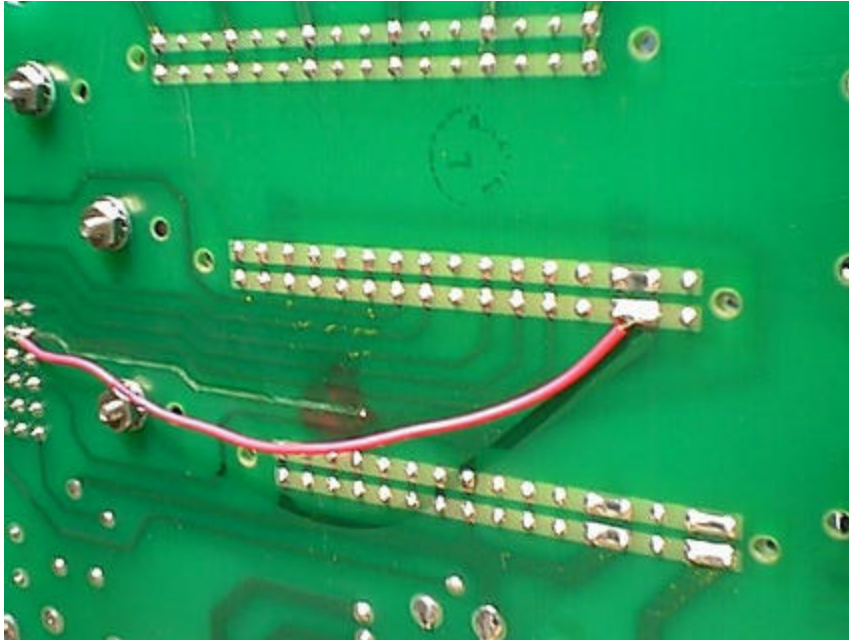
Condition. Tower Dark

Cause: Lightning strike/power surge

It is relatively common to find this printed circuit strip burned open on the back side of the mother board (the one the cards plug into). The symptom will be that there is no power transfer (110vac) to the appropriate pins. In order to repair the problem it is necessary to remove the mother board by taking out four slotted screws in the opposing corners and allowing the board to come free of the weatherproof box in which it is housed. You will note that the printed circuit has been burned open and there may even be a matching burned place on the weatherproof box.. Remove loose and burned printed circuit material by pulling it away from its surface. Make sure there is no printed circuit left. When you are sure you have the two points that need to be connected located on the board, solder a short length of wire between the points. Often, this is the only problem with the entire strobe unit aside from perhaps a blown fuse. Reassemble and power the assembly and your strobe should work.
