Honeywell

FlashGuard 2000B Medium Intensity Lighting System Troubleshooting guide

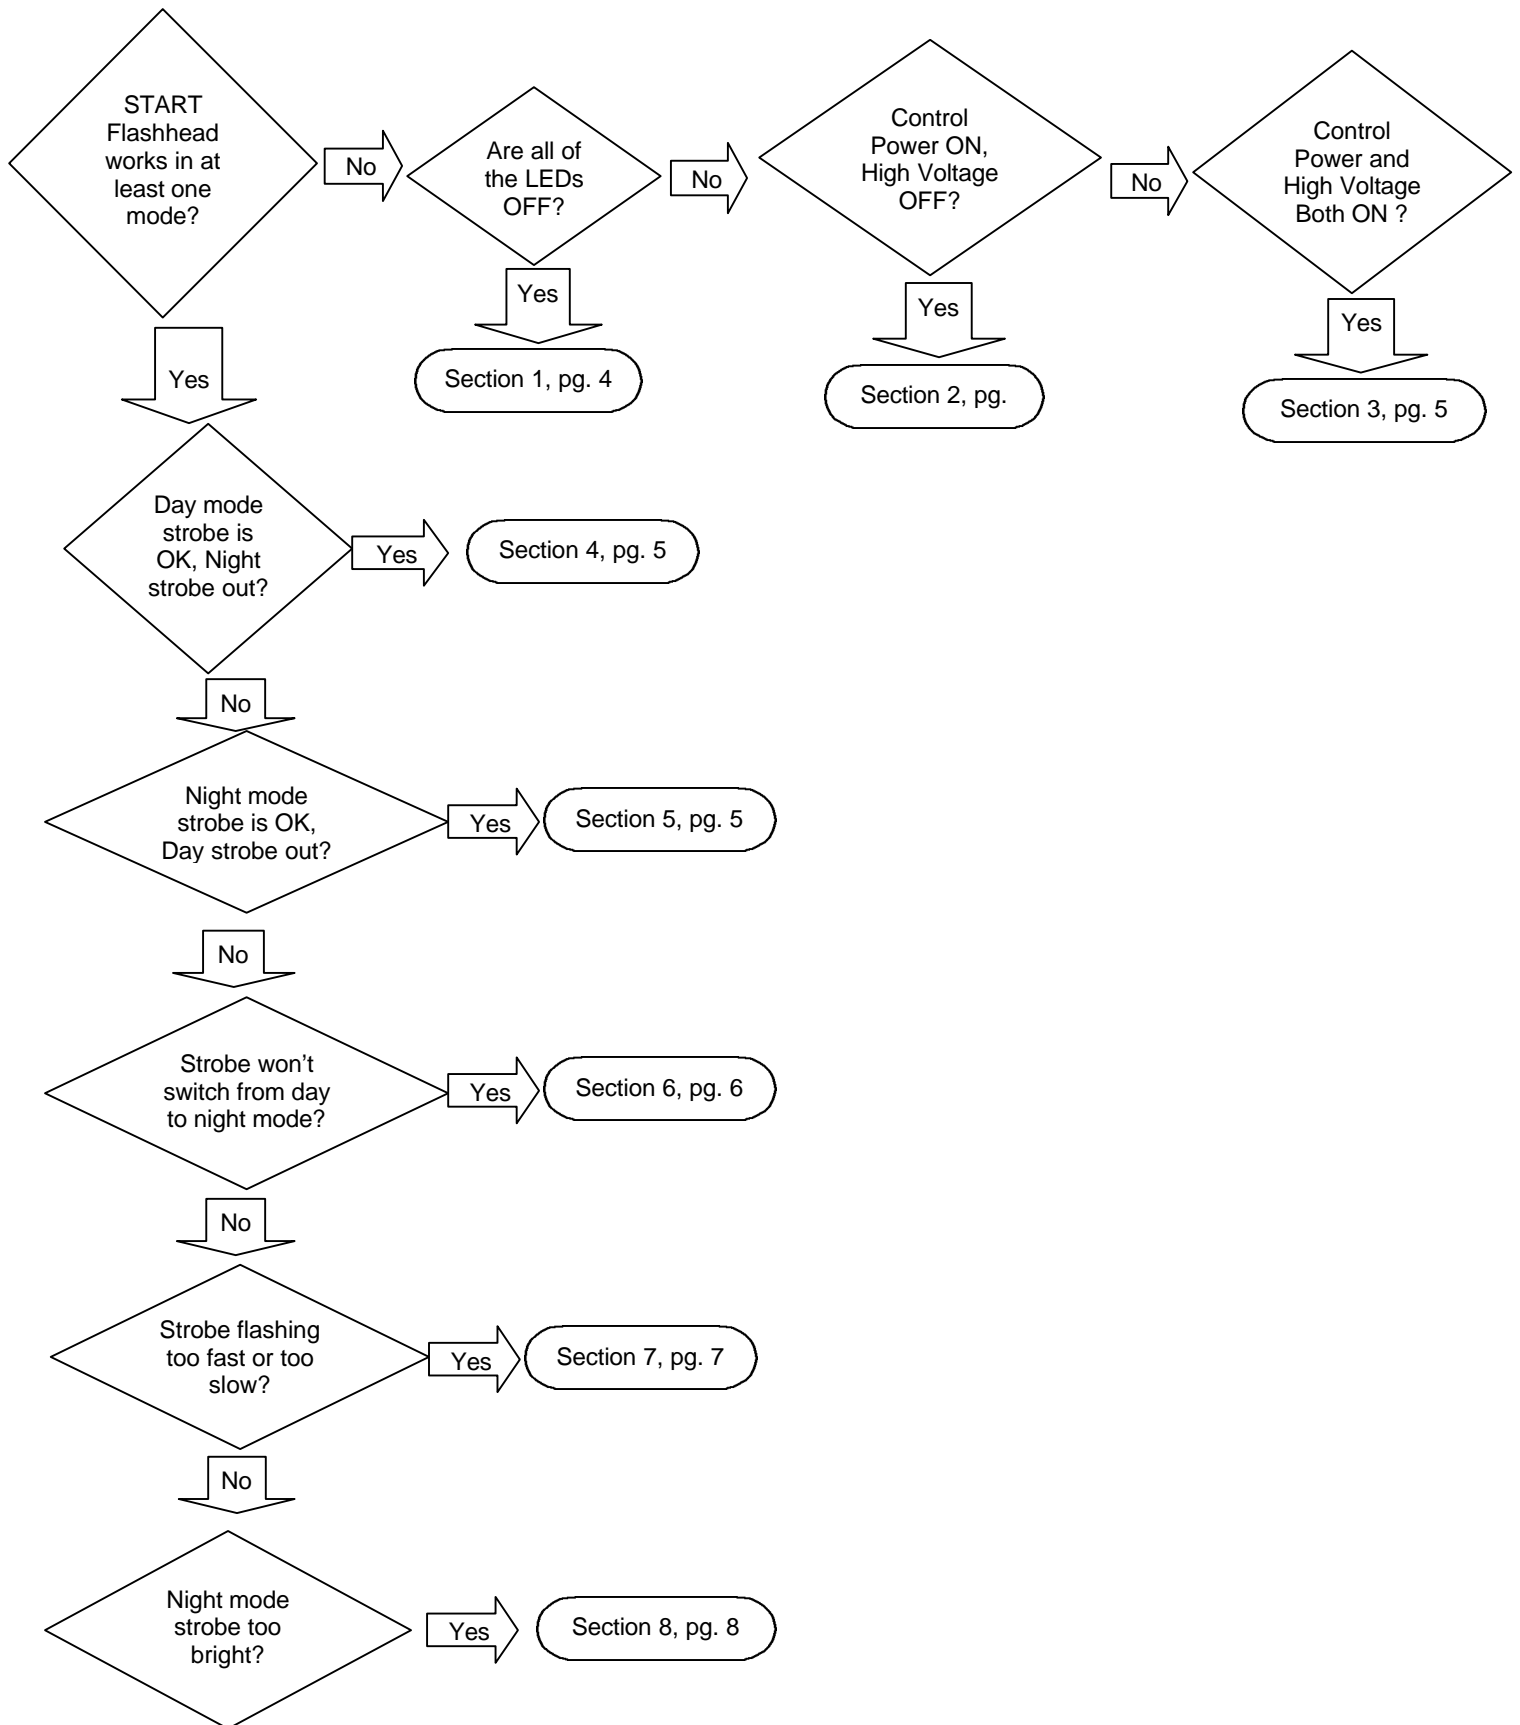
Flashhead (Strobe) Problems

FLASHHEAD (STROBE) PROBLEMS

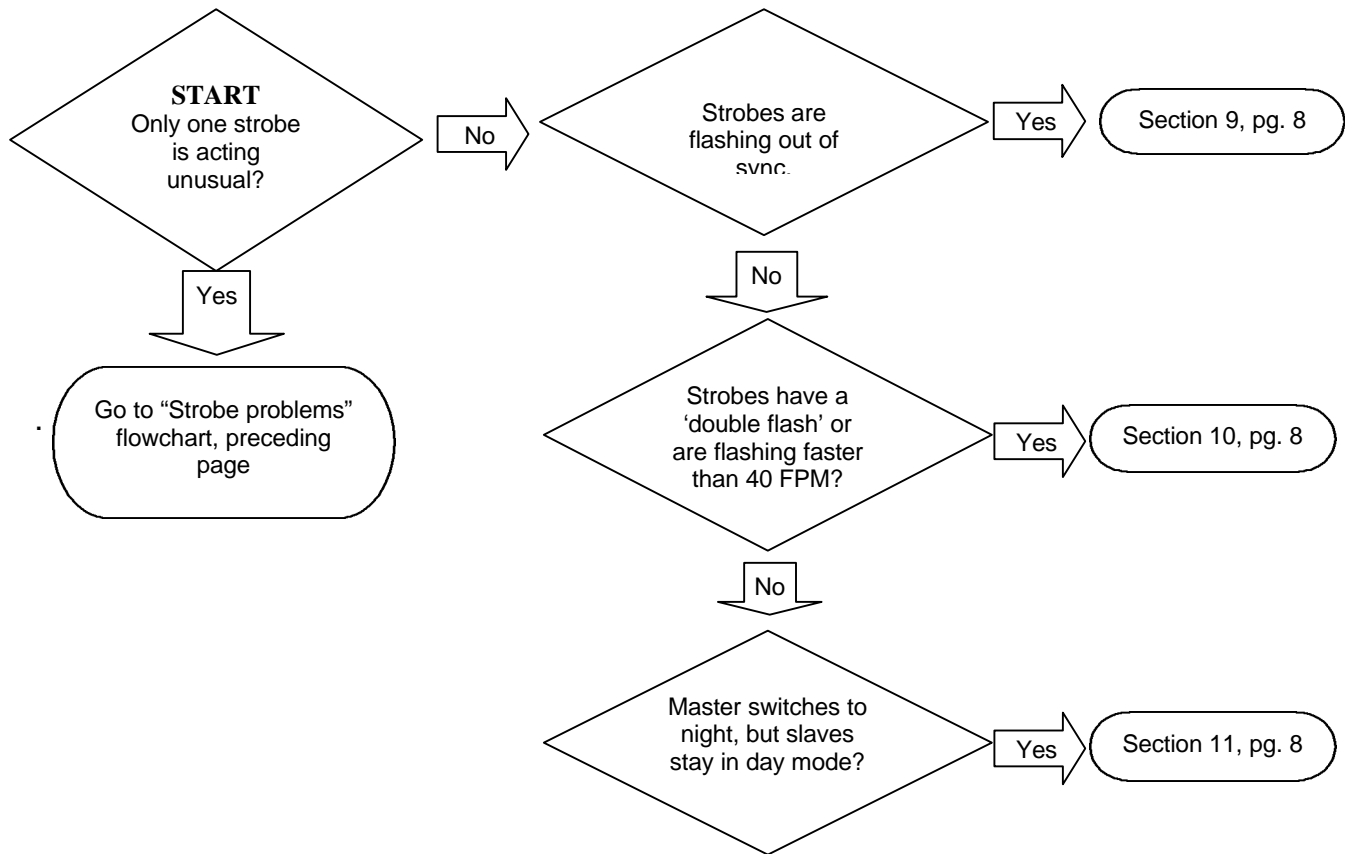
Multiple Strobe Problems

MULTIPLE STROBE PROBLEMS
